# GEOTECHNICAL INVESTIGATION

DYM RESIDENCE  
7720 NORTH HIGHWAY 1  
LITTLE RIVER, CALIFORNIA

Project Number 12934.01

May 4, 2020

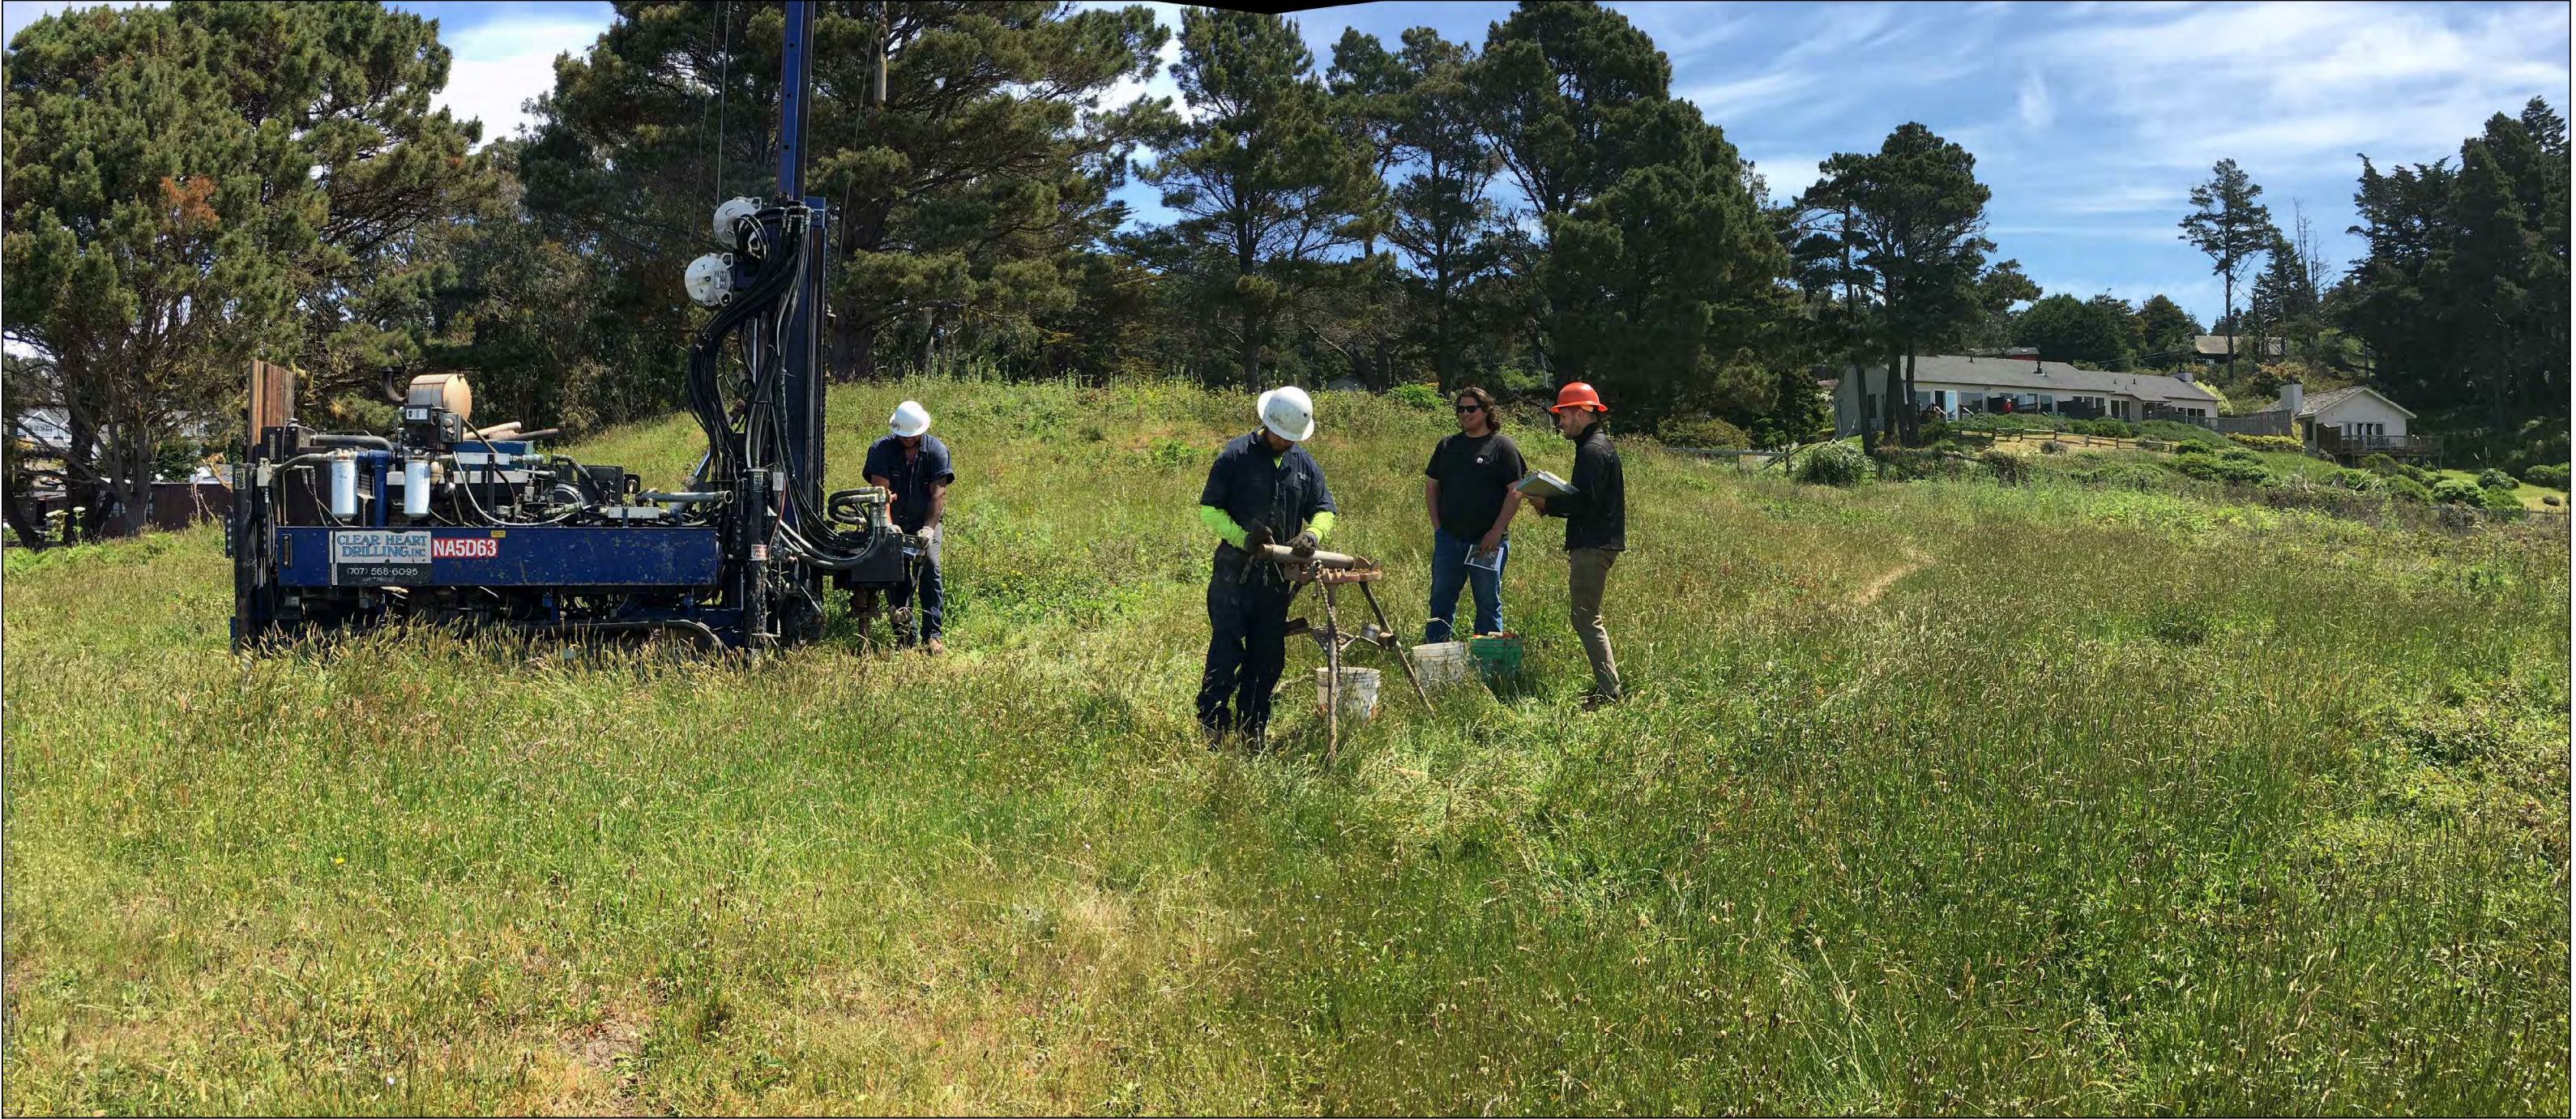
**SITE PHOTOGRAPH A**  
DYM RESIDENCE  
7720 North Highway 1  
Little River, California

Looking east at proposed building site

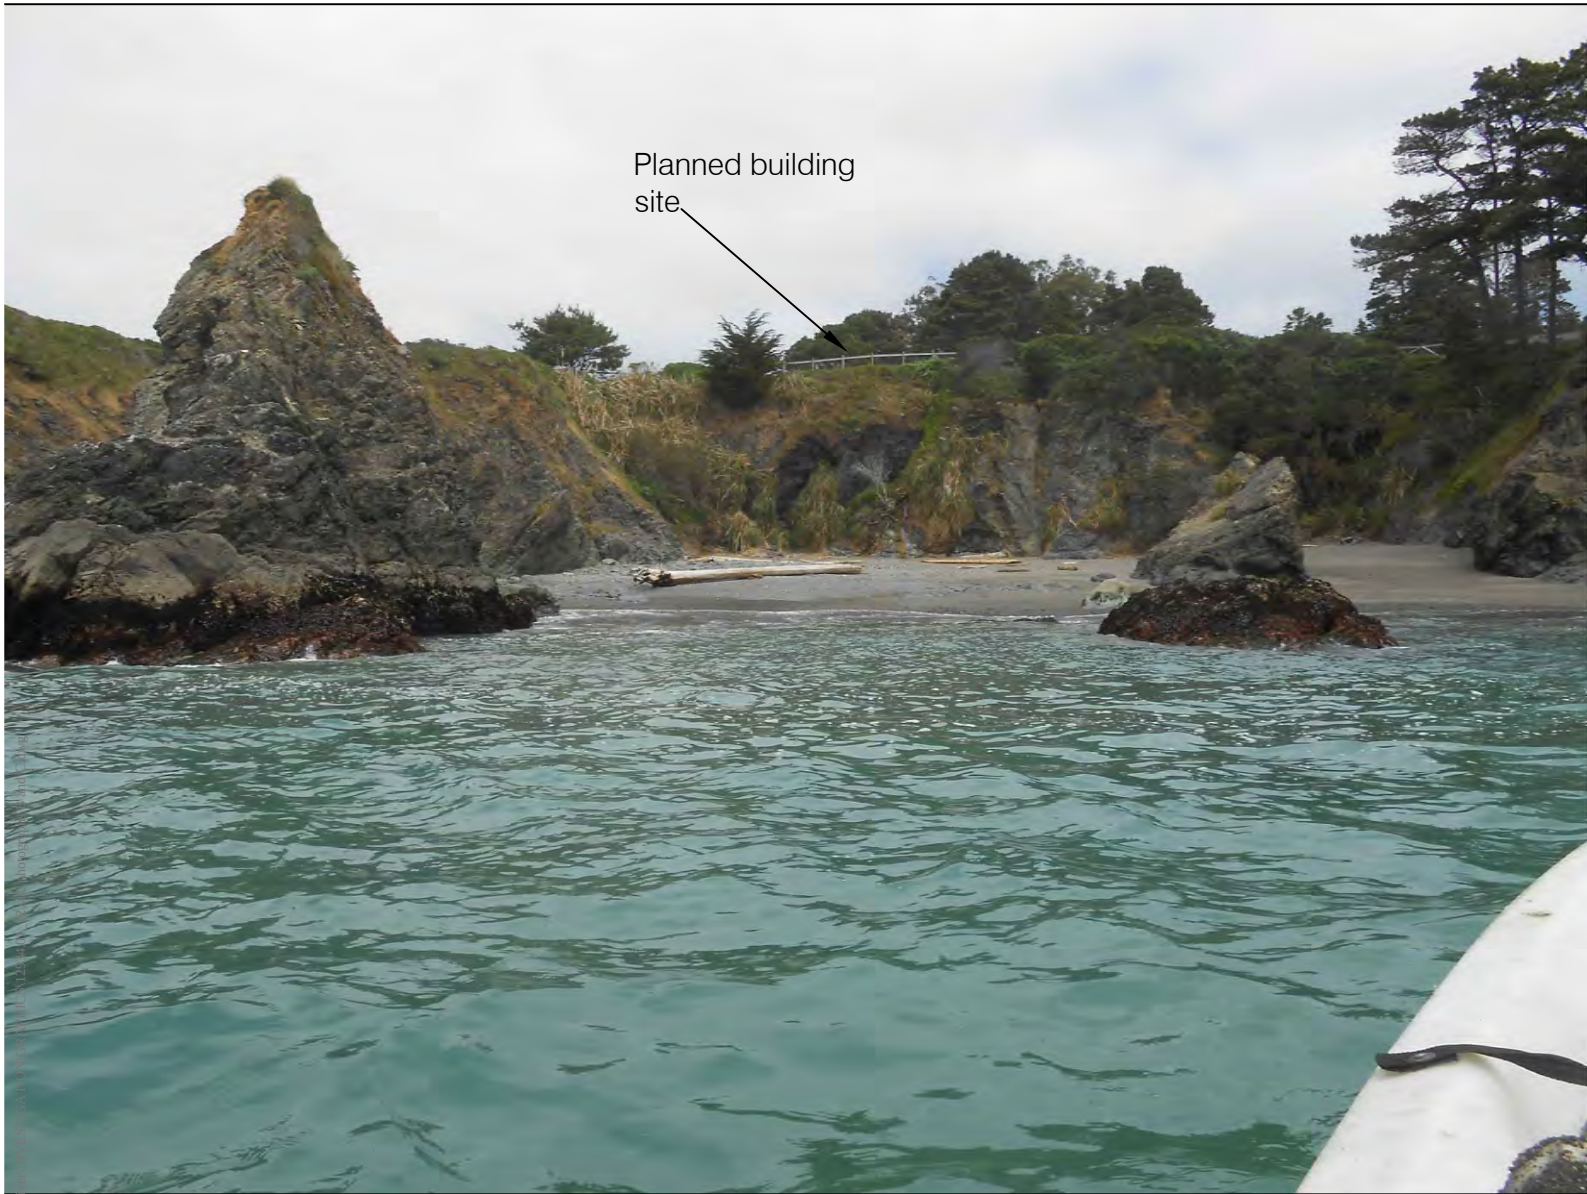
Site Photograph B

Looking northeast

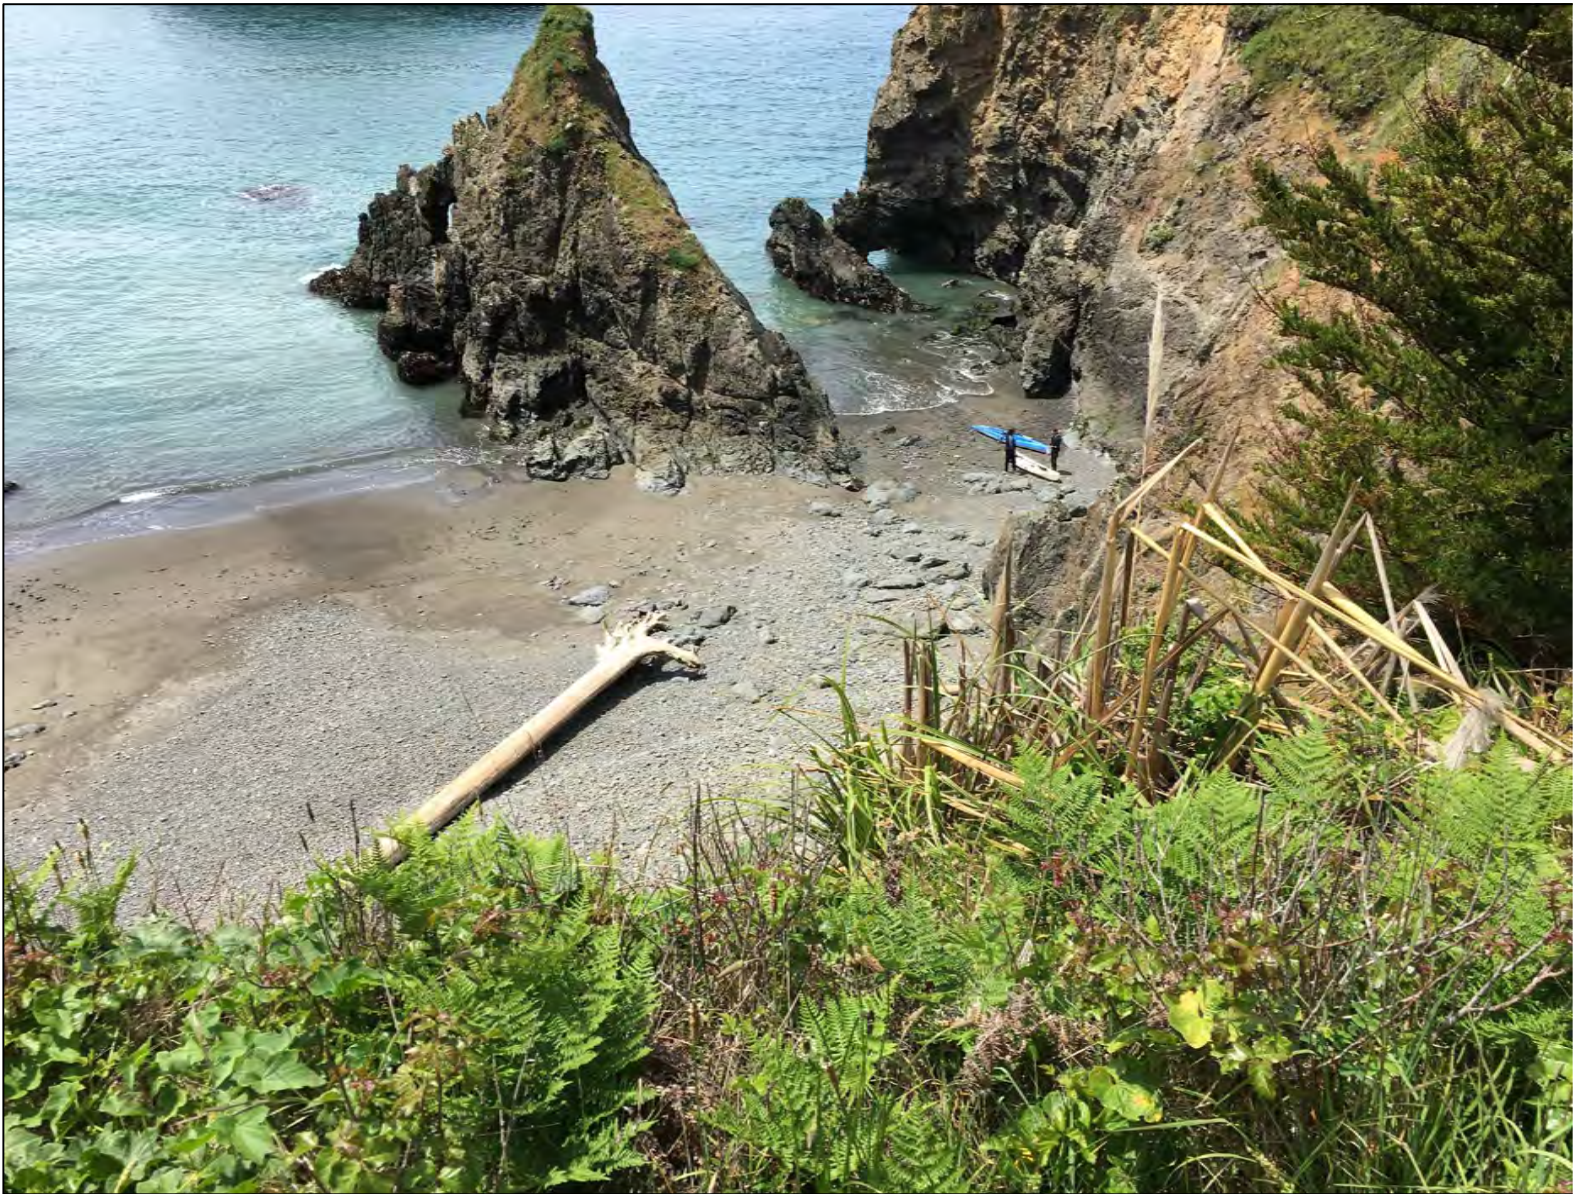
Site Photograph C

Looking southwest from bluff near building site

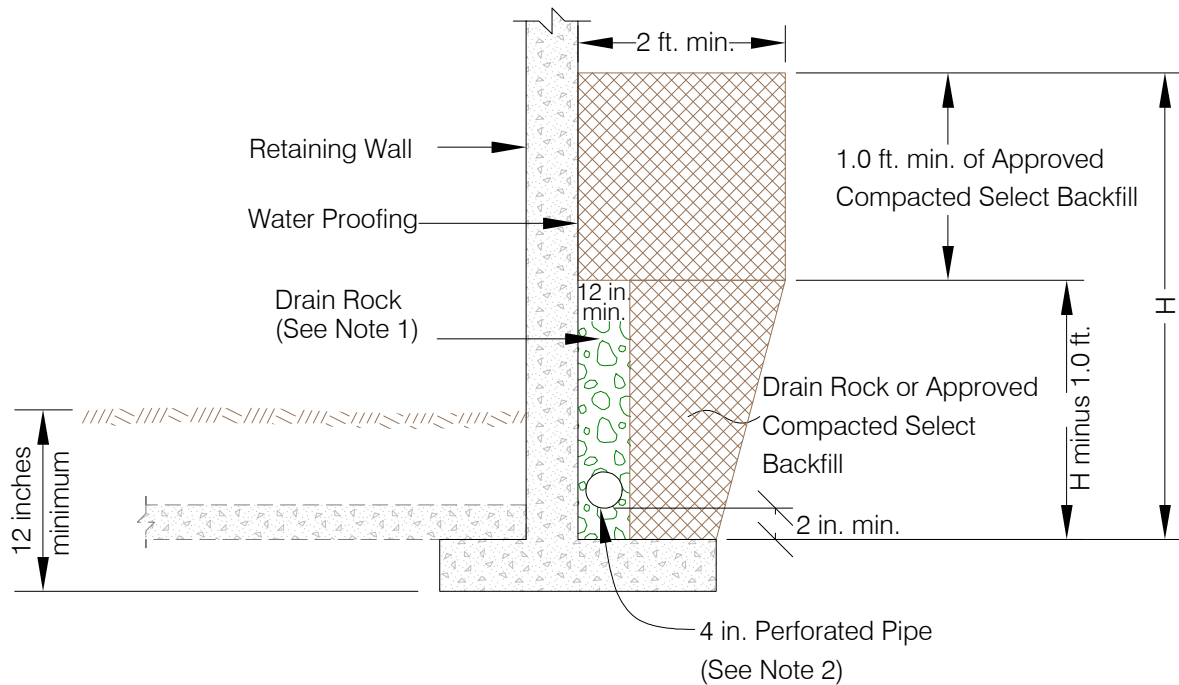
**PLATE  
17**

Subsurface or retaining walls should be provided with permanent back drainage to prevent buildup of hydrostatic pressure. Drainage and backfill details are presented on Plate 17. In areas where movement of moisture/vapor through the wall would be detrimental to its intended use, installation of a vapor retarder membrane should be considered. Construction of vapor retarders does not guarantee the prevention of moisture moving through concrete walls. Retaining walls should be designed to resist the lateral earth pressures presented on Plate 18. If a wall drain is not practical, subsurface walls should be designed for full hydrostatic pressure.
